Capital Improvement Projects Submission

Addition/Renovation To Computer Facility

Public Works Project Number: 15-01

Renovations to Mountain Top Communications Sites

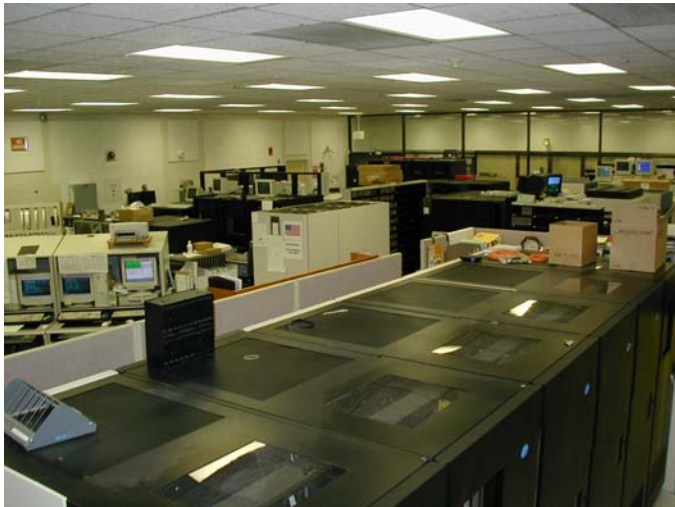
Computer Room Floor – 2002

Presently the Computer Facility is 14,400 square feet. 13,000 square feet are for data and telecommunications equipment. 1,400 square feet accommodates 41 onsite personnel. This includes a 375 square foot conference room and hallways.

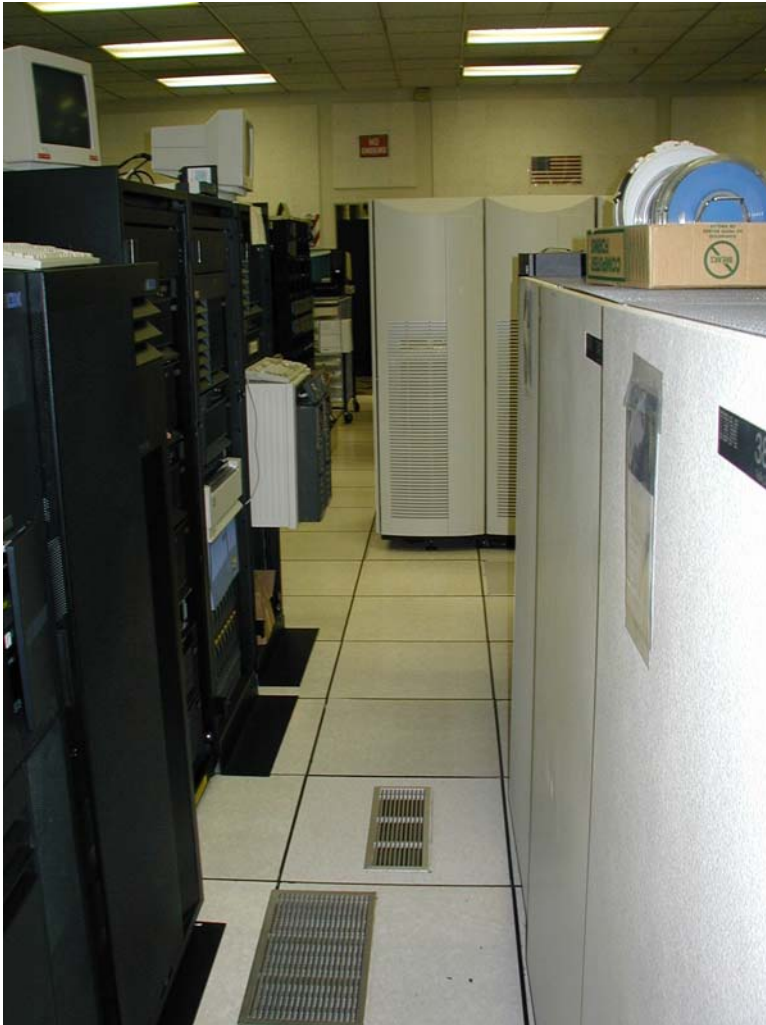
IFS Risk boxes and
tape drives left.
Storage and mainframe
equipment right.

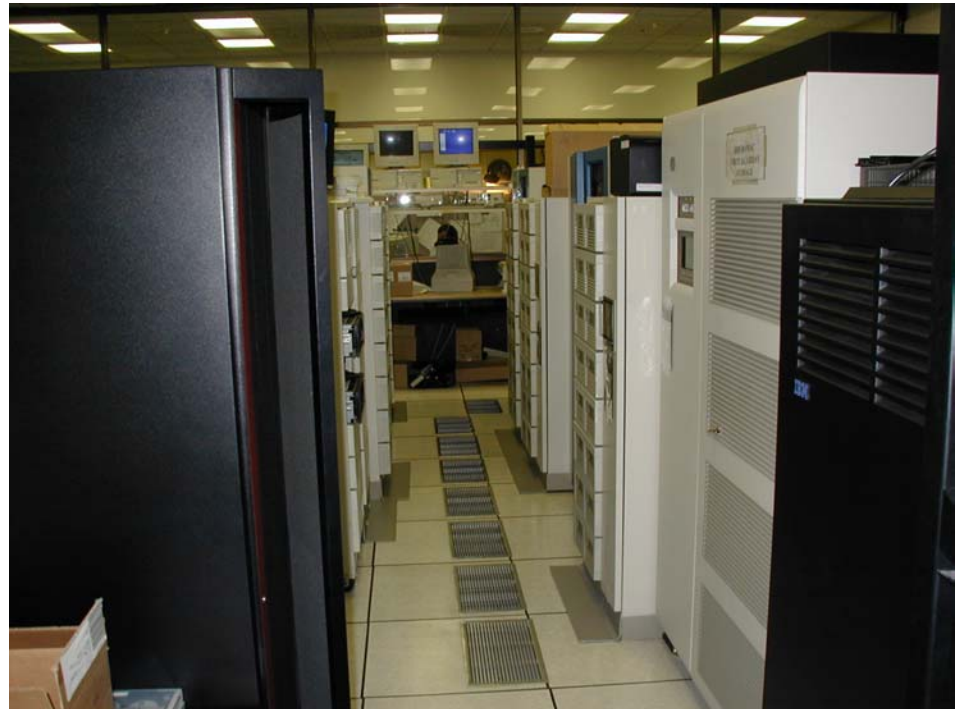
Equipment is densely
packed on the raised floor.

Access to the equipment is
difficult.

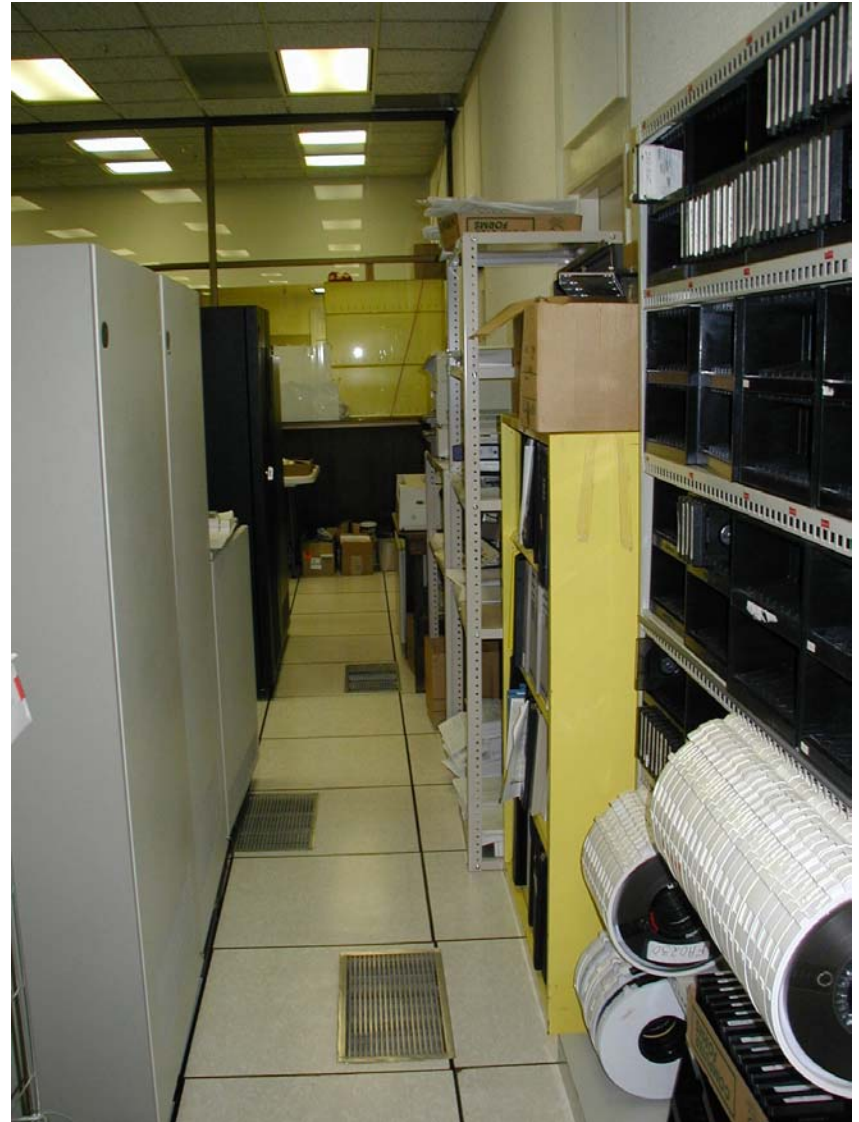
East Wall of the
Computer Room.
Located behind the
VTS (Virtual Tape
System) are racks of
round tapes, software
manuals, and various
machines.

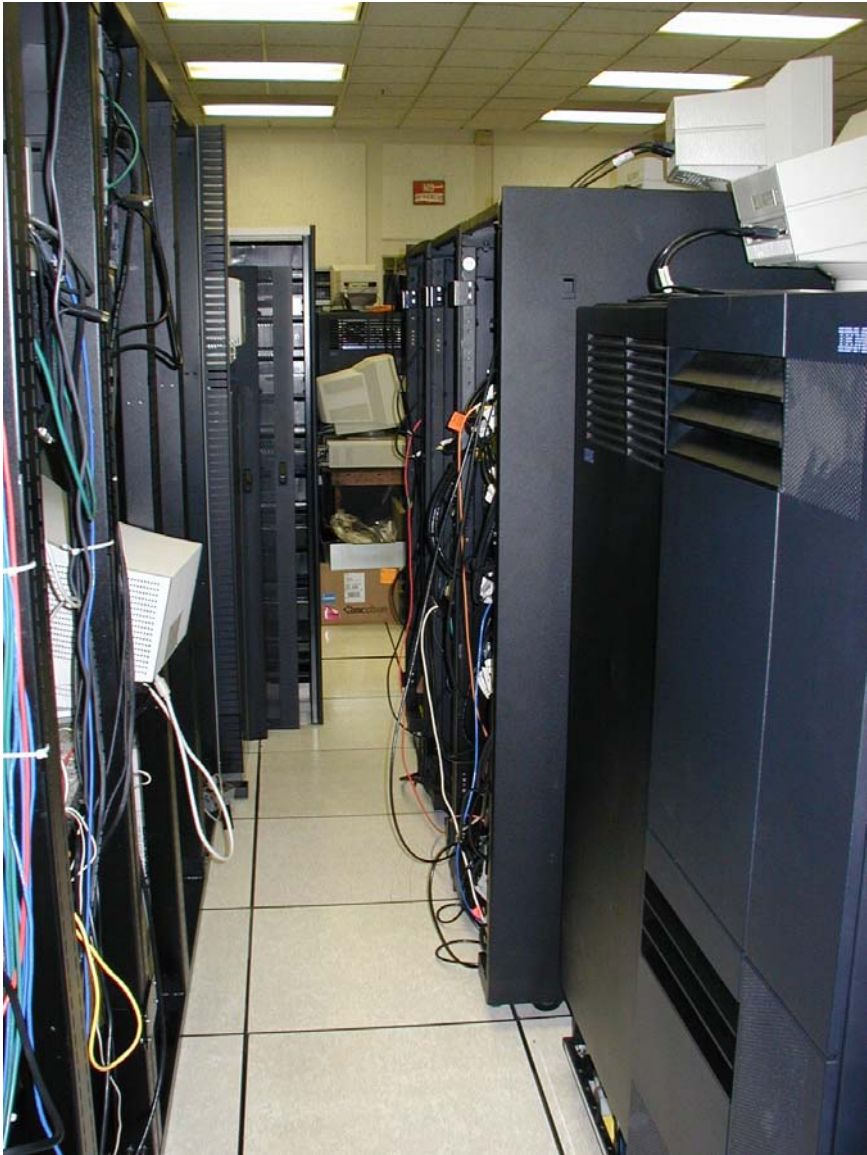
UNIX Boxes and Server Farm

Narrows to 13 inches of
walk space and access
between the equipment

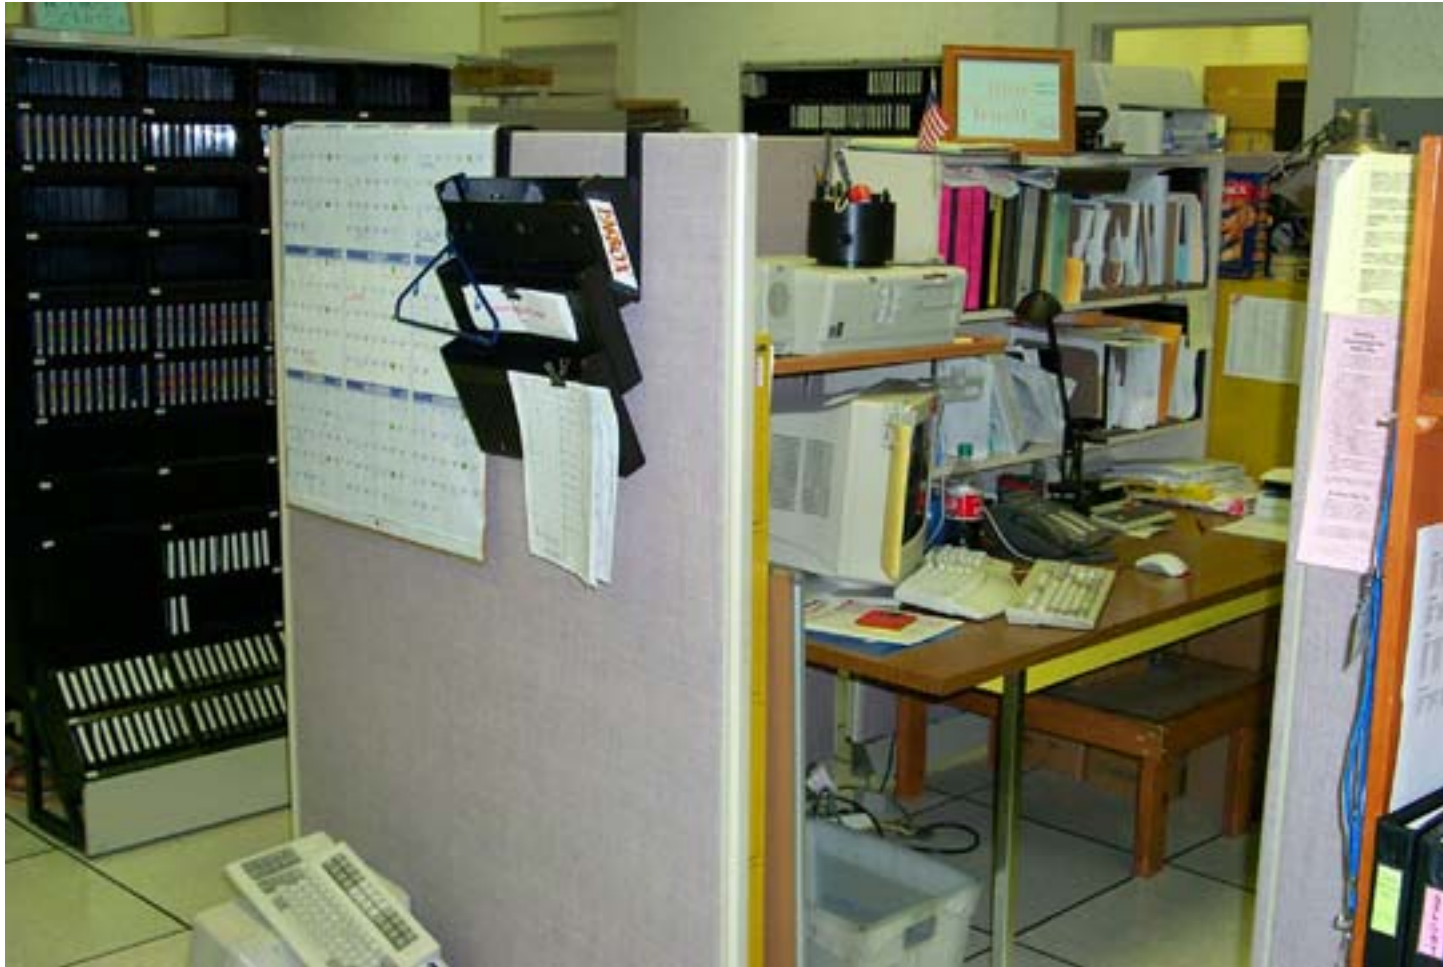
This office, shared by three of the Operations Supervisors, consumes valuable space on the raised Computer Room floor.

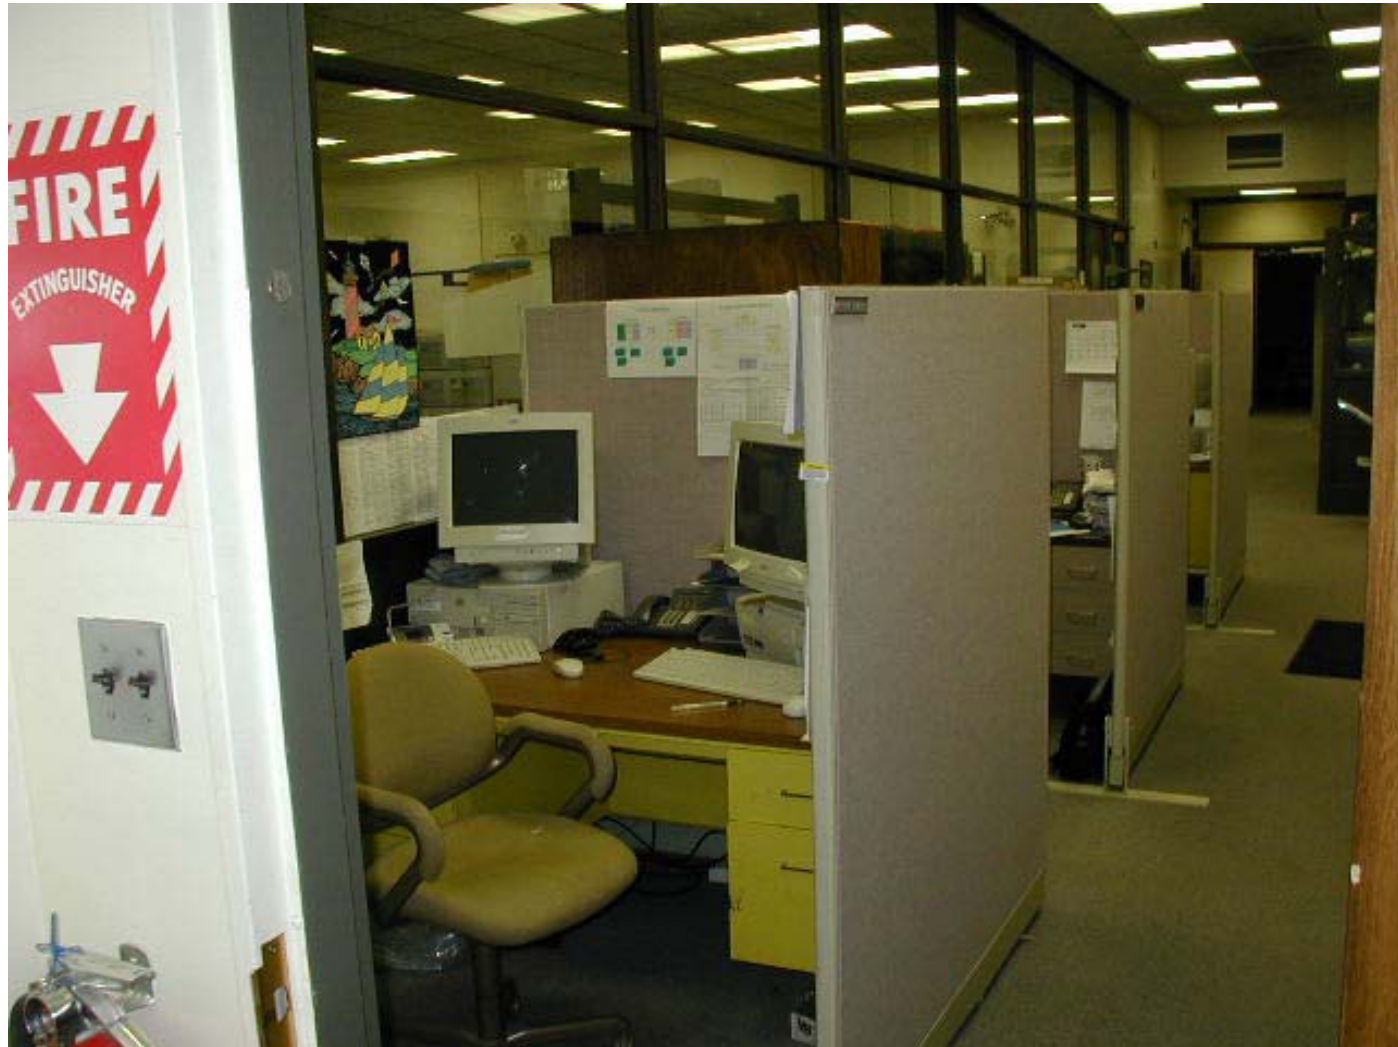
There are five offices in this section of the building, formerly a hallway.

Average office space is 5 feet long by 5 feet wide.

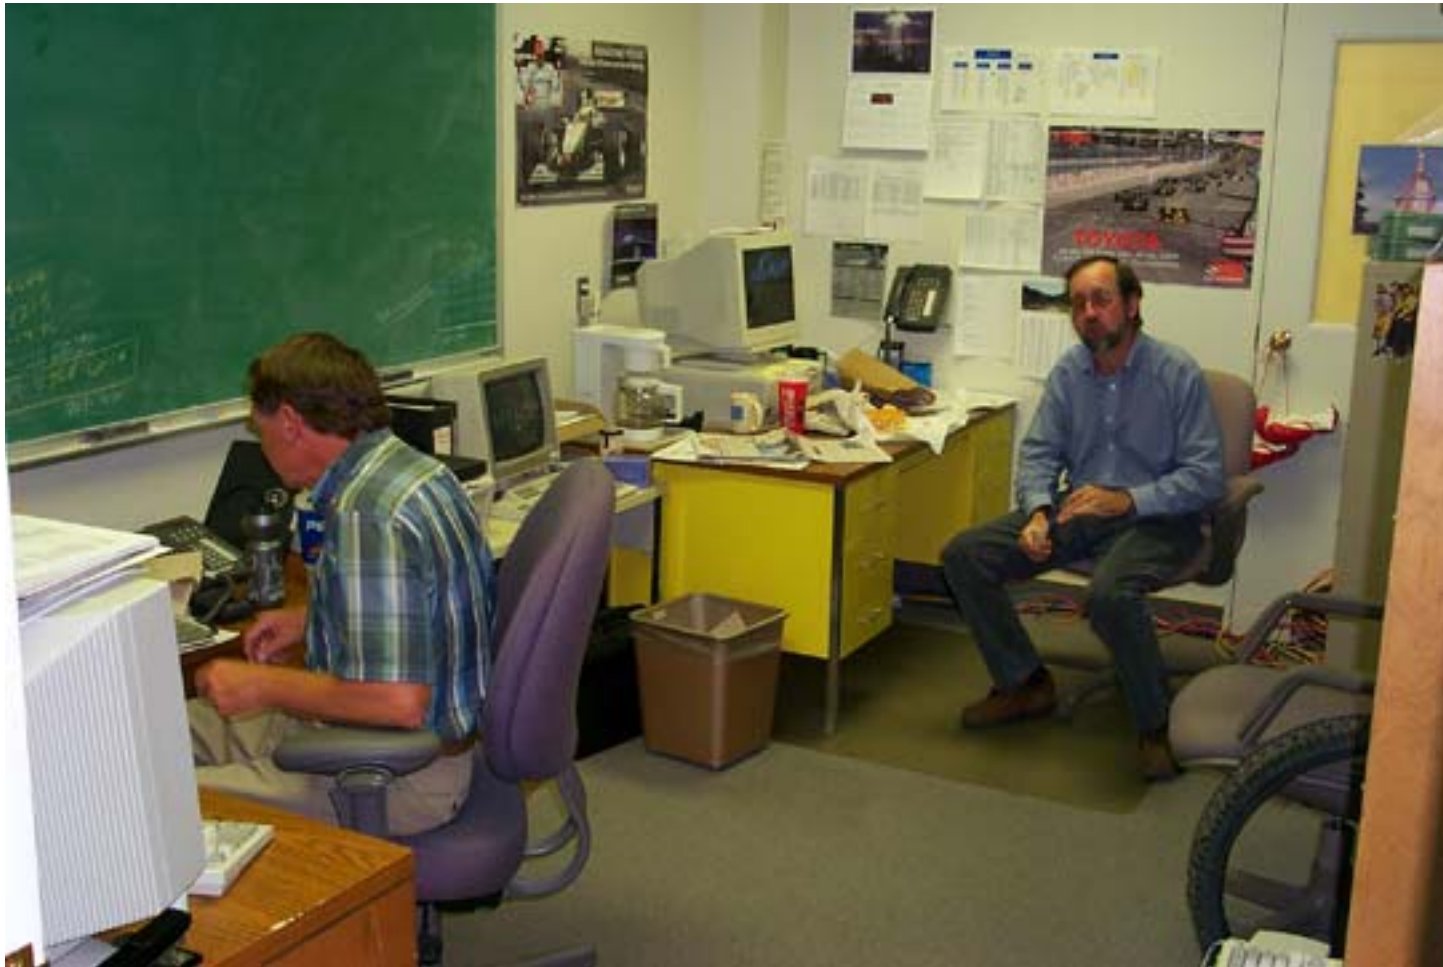
The Systems Manager and Network/Security/Unix Manager share an office resulting in lack of privacy.

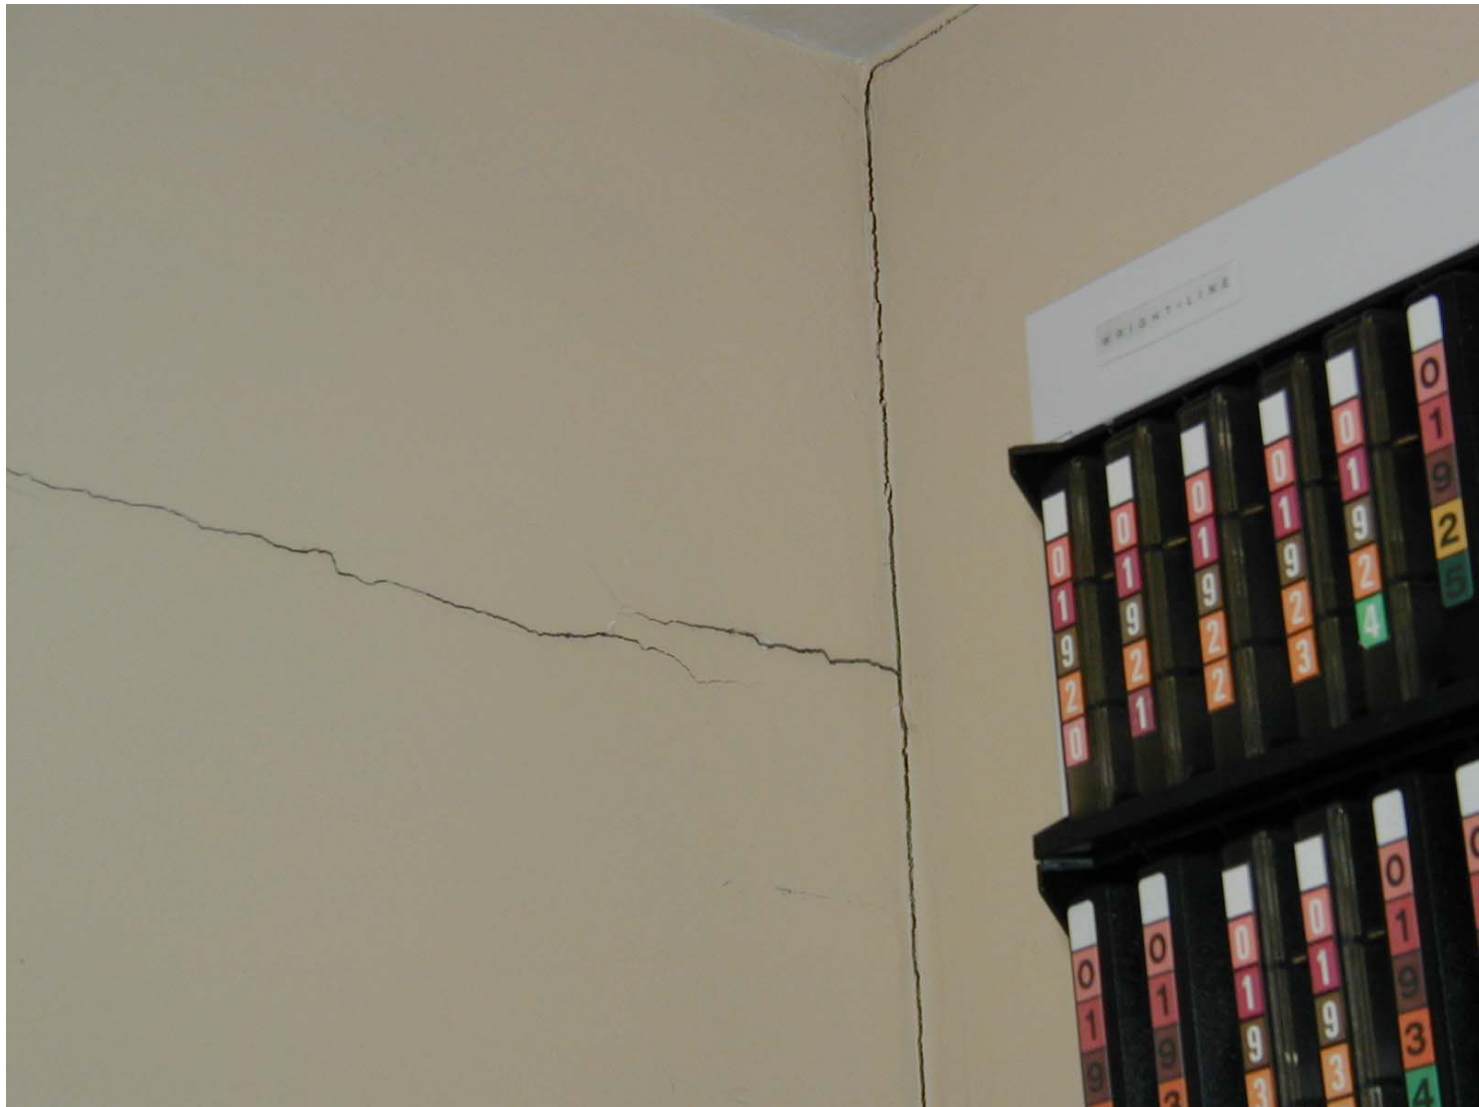
The crack in the wall and ceiling of the tape vault is one of many found throughout the building.

- General space remodeling of office areas
- Updating the raised flooring system to meet current seismic design
- Converting existing Halon fire suppression to standard ENERGEN or FM-200 equivalent
- Replacement of the Edwards Fire Alarm panel due to obsolescence
- Installation of a perimeter fence that encloses the parking lot
- Resurface the existing parking lot to eliminate hazardous cracks and sink holes.

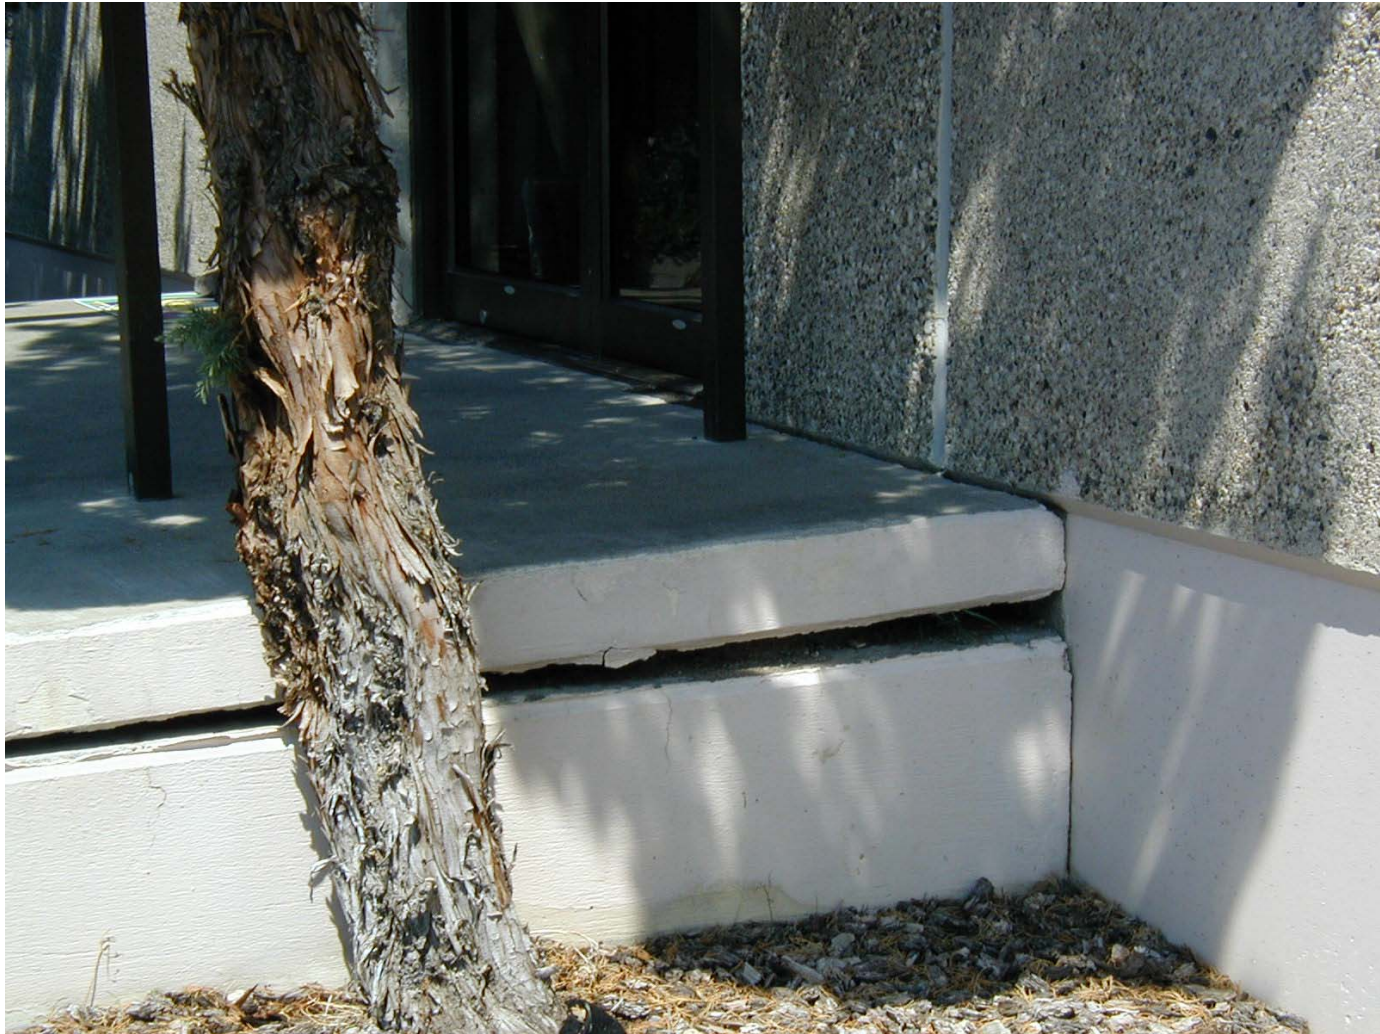
An example of settling, the concrete steps outside of the building are separating. Several other examples can be found on the exterior of the building.

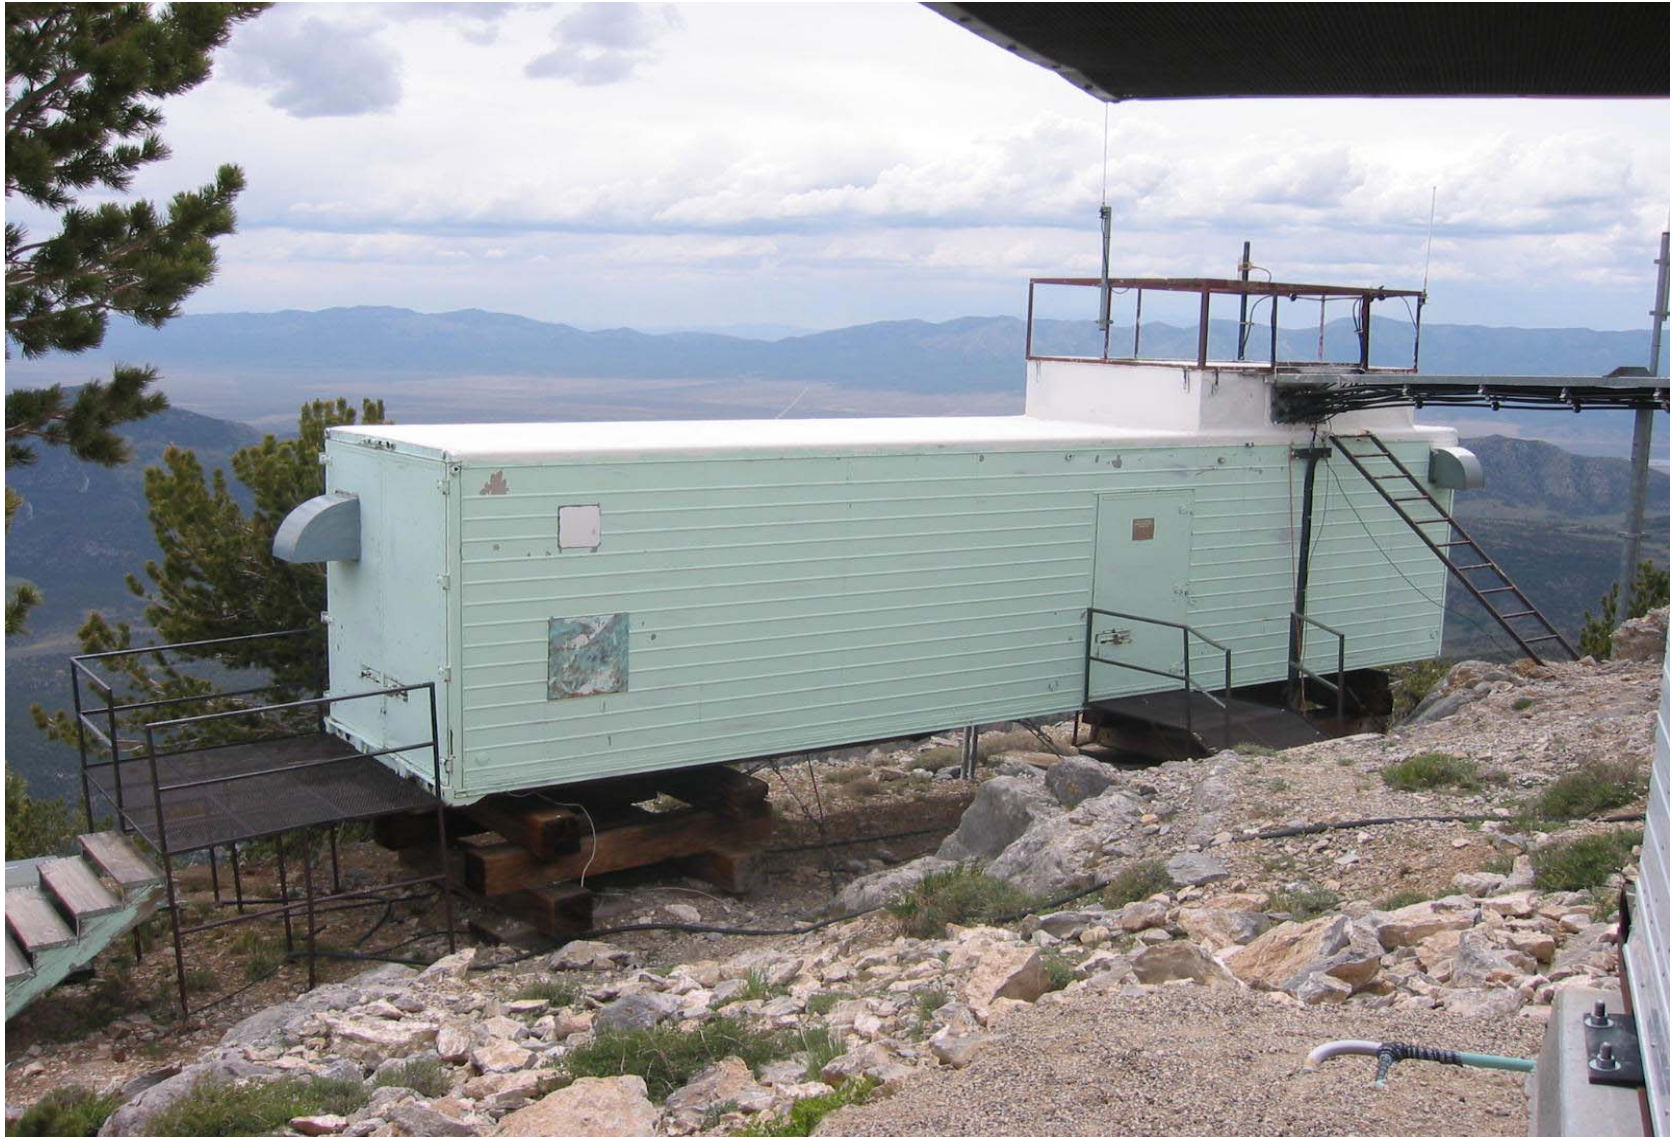
Montezuma Peak - Installed 1971

- **AGE - EARLY '70s INSTALL.** 5 of 6 sites were constructed 30 years ago, in the early 1970's. One was constructed by the Air Force in the mid 1950's.
- **SURPLUS TRAILER VANS.** Most site shelters are converted surplus box transport trailers having the wheels removed. They were already old in 1970. Bullets pass right through them.
- **ORIGINALLY TEMPORARY.** The trailers are simply placed on railroad ties. At the time of installation it was the expectation they would be temporary.
- **VULNERABLE MODIFICATIONS.** Modifications to the trailers was required to accommodate the equipment and racking. Sections of the trailers had roof sections cut out and vestibules added.
- **LEAKAGE.** Rust, corrosion, damaged seams and collapsed roof structures have allowed water, dust, cold and heat to damage sensitive electronics. Roof top maintenance is an annual occurrence.

Typical 1970's Site Installation

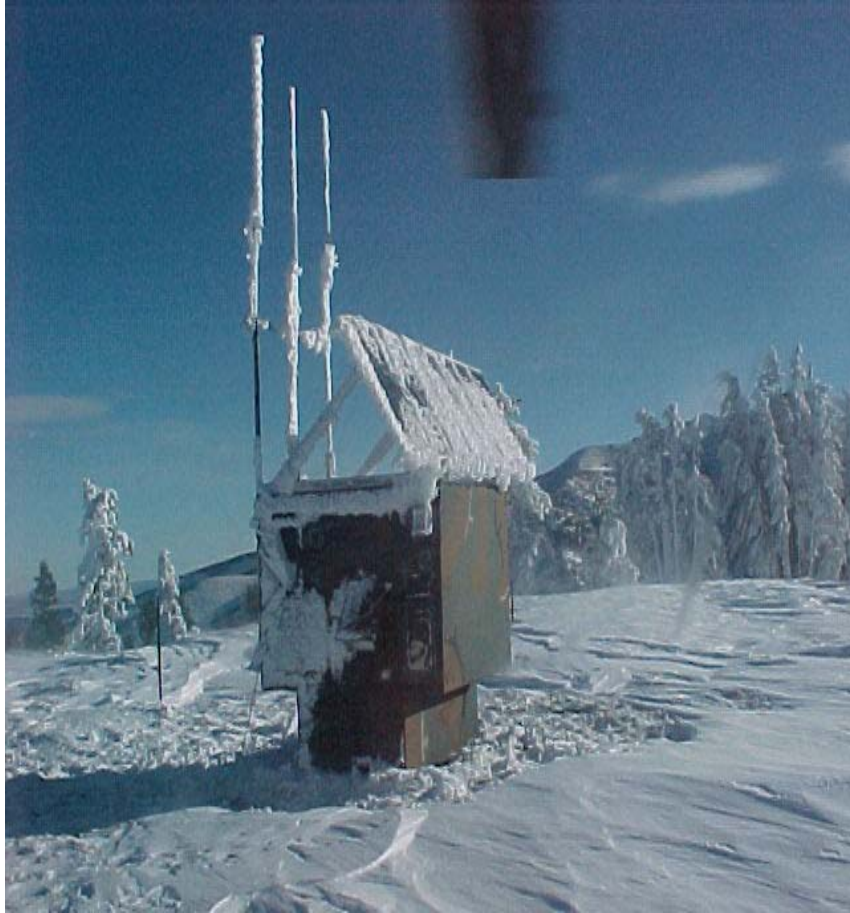
Surplus Shelter

In their present condition, these six communication sites are a continuing problem and threat to public safety and state communications
